## 9 Case Studies

### 9.1 Case Study 1: AGC Lessons Learned at the former Camp San Luis Obispo

## 9.2 Example Case Study 2: Soil Processing

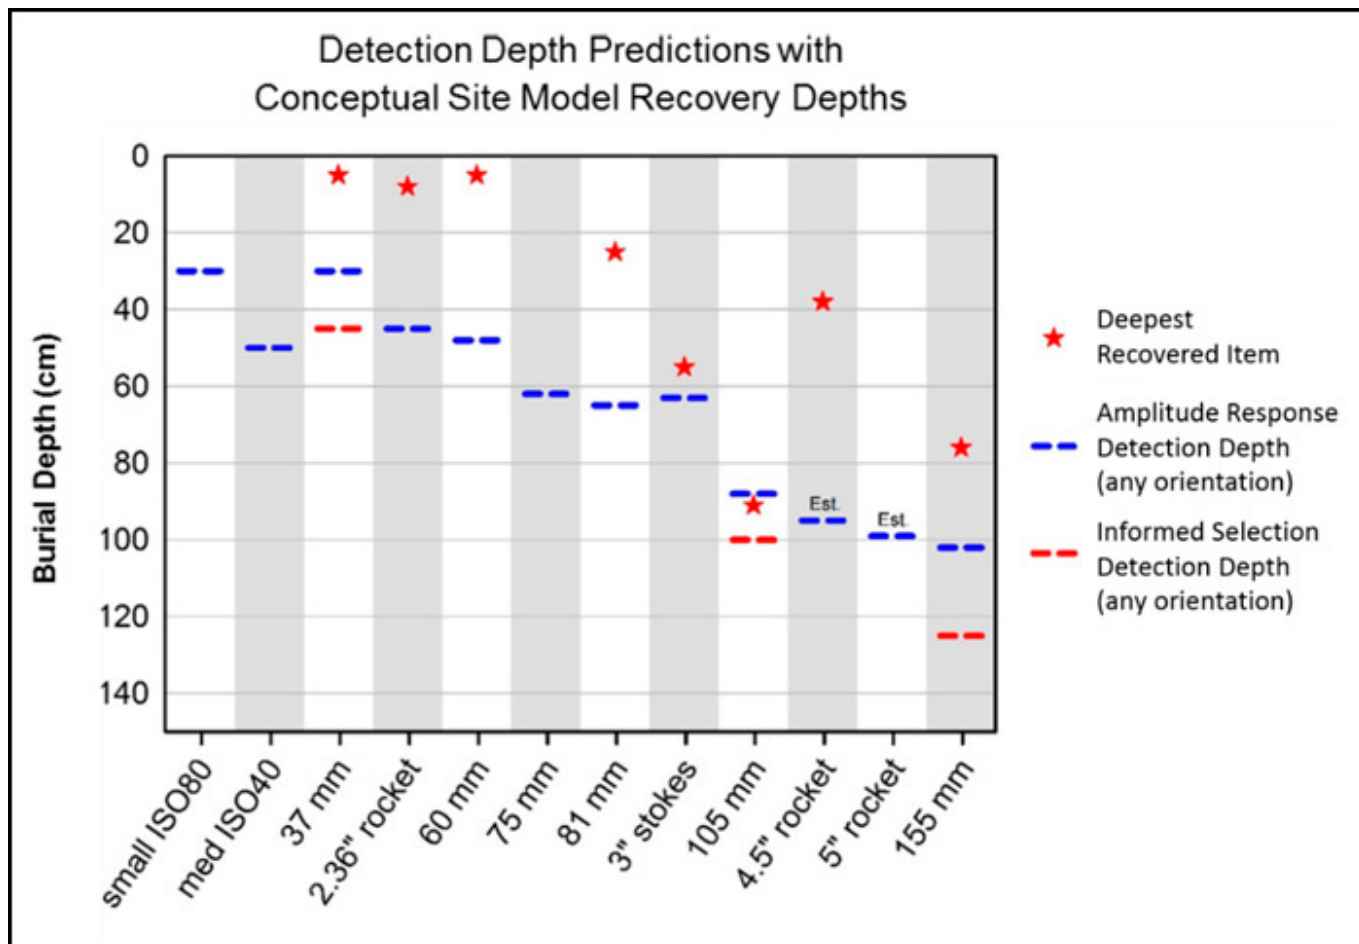
**Figure 9-2.VCSM. Maximum reliable depths of detection for munitions identified in the CSM.**

The planning process began with preparation of the UFP-QAPP in which DQOs were established using the USEPA's 7-step process. The specific DQOs are documented in Worksheet #11 of the UFP-QAPP. The detection/classification objective of the project was to detect and classify munitions equivalent to a 37mm projectile at a depth of 30 cm. This objective requires that munitions larger than 37mm projectiles be detected to the depth at which they would provide the same response amplitude as the 37mm projectile at 30 cm. The vertical CSM shown in Figure 9-2 shows the maximum reliable depth of detection for the munitions anticipated to be present at the site. In this figure, blue lines represent conventional amplitude response detection depths and red lines represent detection depths using ISS. Red stars indicate the deepest depth for actual TOI recovered from the site. The maximum reliable depth of detection is based on the munition being at the least optimal position and orientation under the sensor. Munitions with more optimal positions and orientations are detected at greater depths.

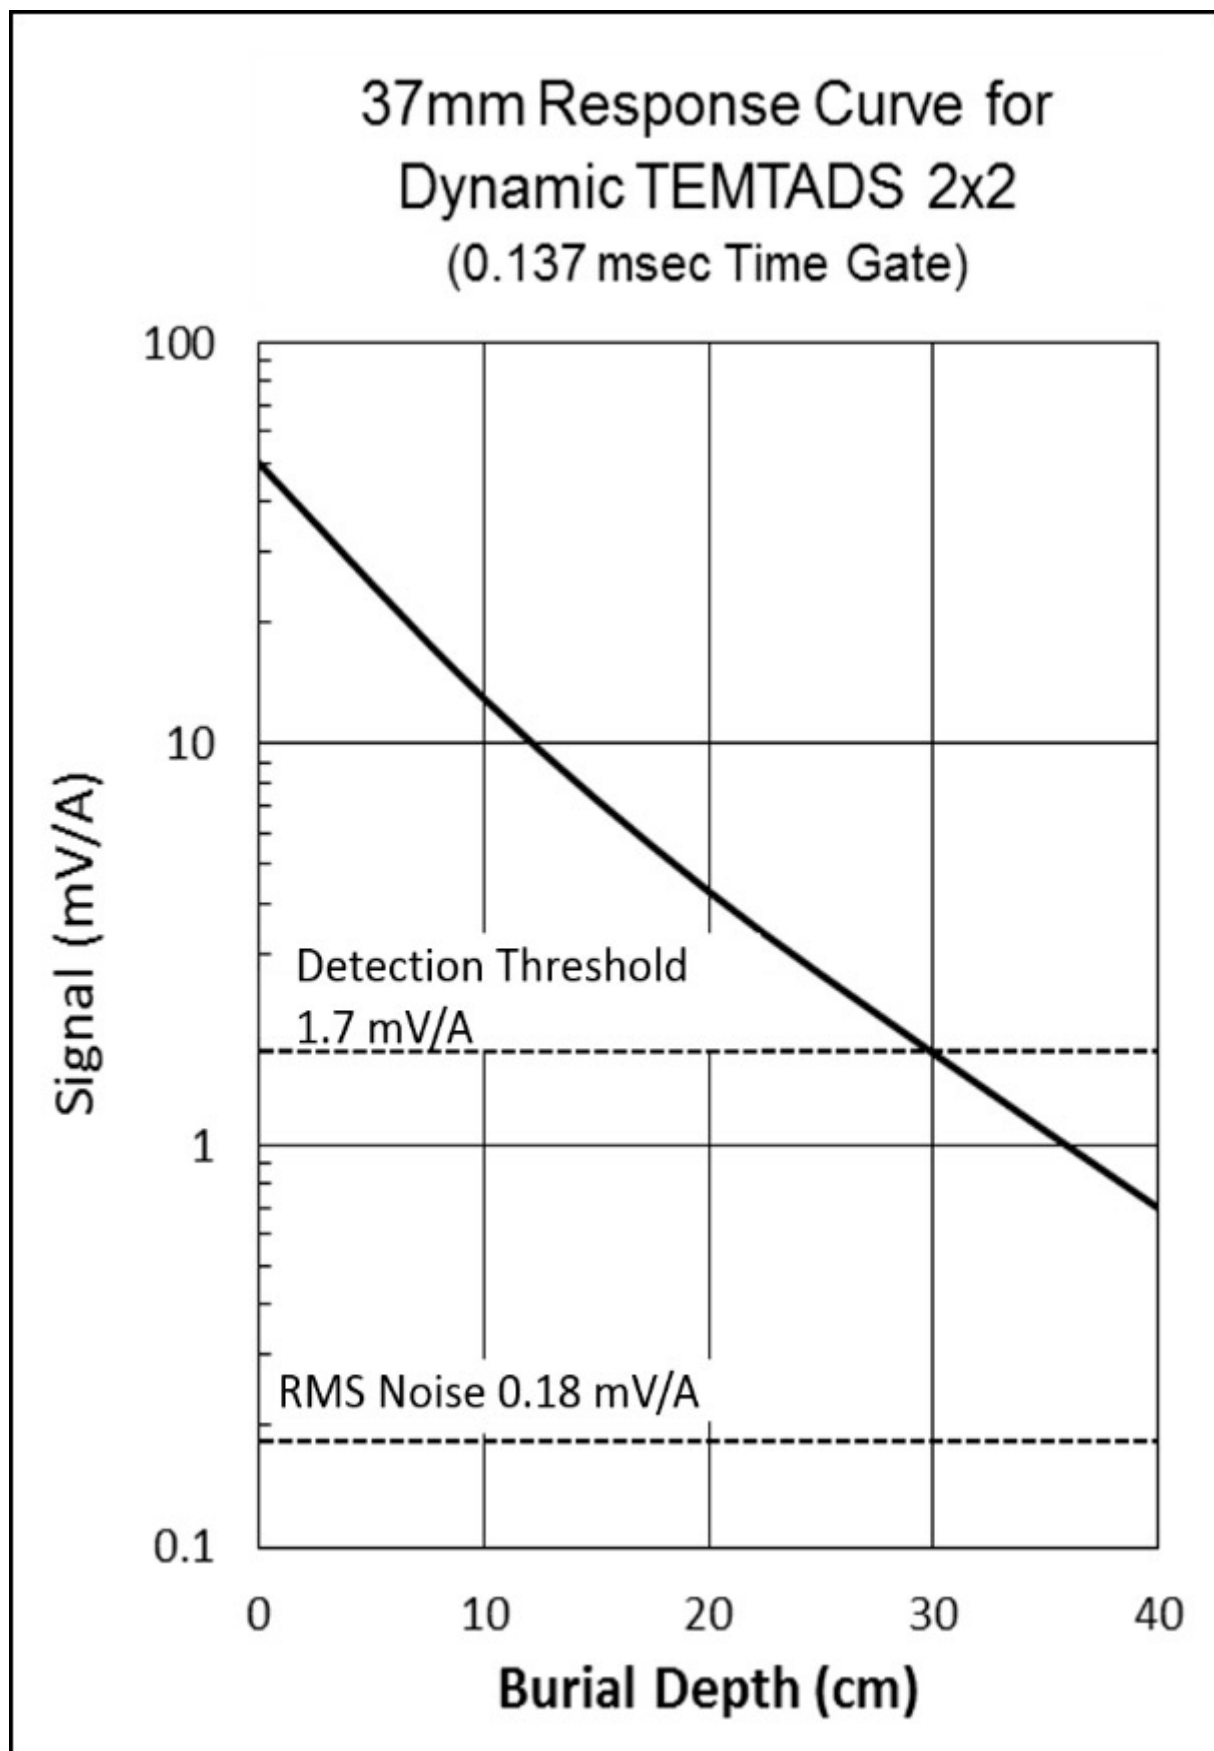
**Figure 9-3. Detection threshold.**

Figure 9-3 presents the modeled worst-case response as a function of depth. In this figure, the solid line presents the modeled TEMTADS 2x2 response to a 37mm projectile at its worst-case orientation and position relative to the sensor. At the detection goal depth of 30 cm, the modeled response is 1.7 mv/A (upper dashed line). The lower dashed line presents the site-specific noise resulting in a signal to noise ratio of 9.4. The project depth of investigation requirements resulted in an SNR of 10.

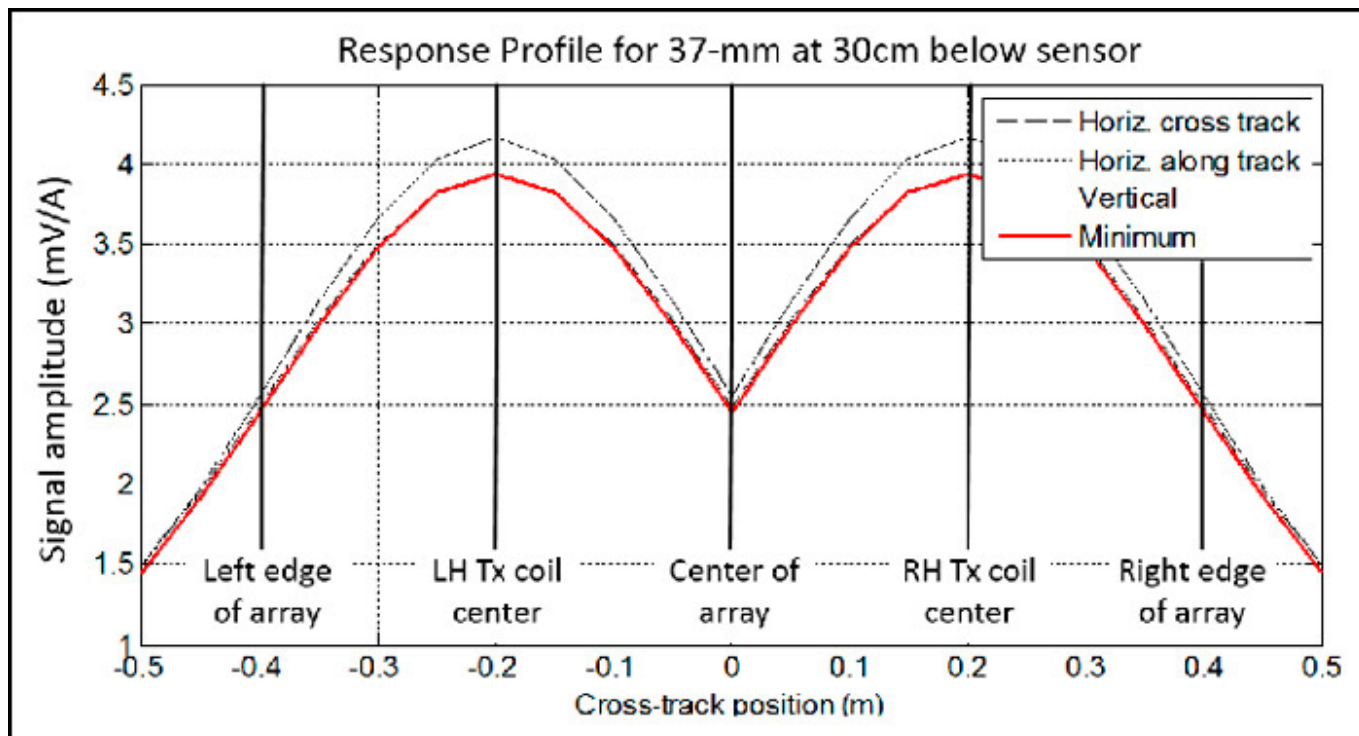
**Figure 9-4. TT response profile.**

*Repeatability of dynamic survey response amplitude over IVS items.* The MQO for repeatability of dynamic survey response amplitude over IVS items was initially  $\pm 25\%$ , but it was discovered that the MQO was not being met even though all other aspects of the system and survey process were in accordance with QAPP specifications. Upon further analysis, it was determined that the cross-track position of the target relative to the array results in larger signal response variations than are allowed for by the MQO. Figure 9-4 presents the peak amplitude response as a function of cross-track position of the target relative to the sensor footprint. In this figure, modeled response profiles for an object under the footprint of the sensor (-0.4 m to 0.4 m) show considerable variation in signal depending upon the cross-track position of the object. The peak responses occur directly under each coil and the minimum response occurs directly under the center of the array and under the edges of the array (-0.4 to 0.4 m). The failure to meet the original MQO did not represent a failure of the system. Because the sensor response was being verified with much greater precision using function tests (which test the response of a known object at a precisely known position relative to the sensor), it was determined that this MQO was redundant and was not required.

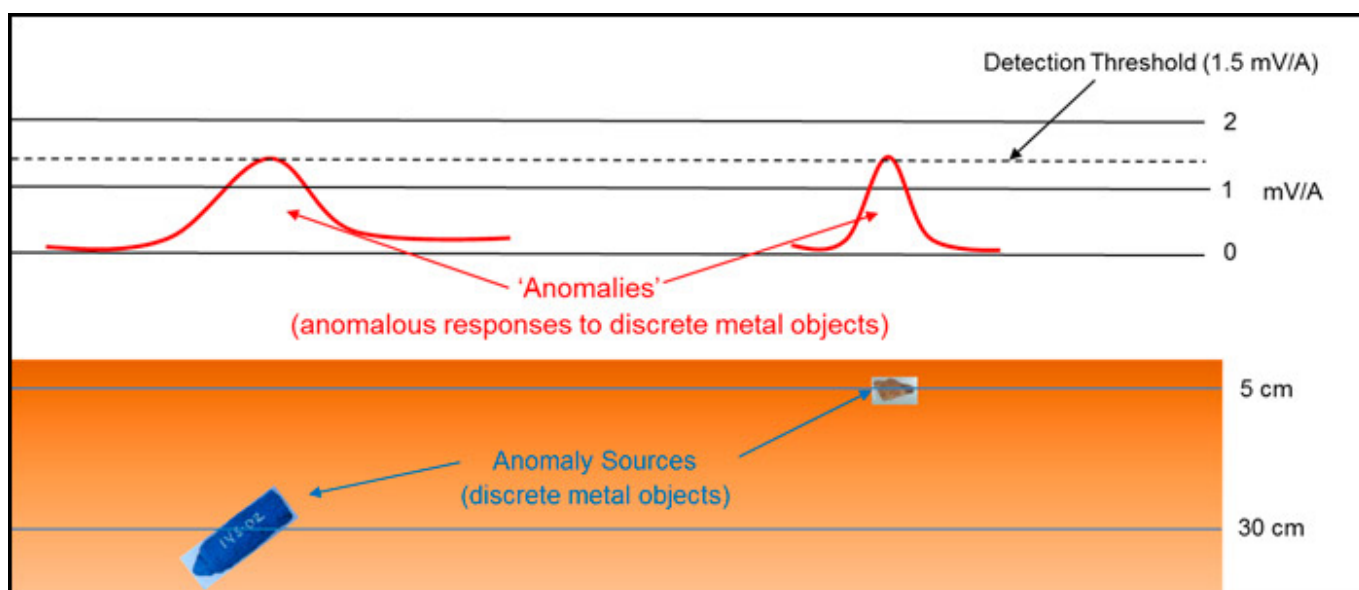
**Figure 9-5. Amplitude response detection.**

*Informed Source Selection Advantages.* ISS is the process by which anomaly sources are characterized using the advanced sensor data set, allowing for rejection of small or thin-walled sources as possible TOI. This process inverts the anomalous data to find intrinsic (size and wall-thickness) and extrinsic (location) feature estimates of the sources. Sources found to be too small or thin-walled to be possible TOI are removed from the target list. The ISS process presents considerable advantages over conventional amplitude response-based detection. Using AR detection, all targets with a response greater than or equal to the response for the smallest TOI at the maximum depth of reliable detection must be selected. As a result, many shallow, smaller targets as illustrated in Figure 9-5 are also selected for further investigation. This figure shows that the amplitude response to small, shallow sources can be as large, or larger than the project detection threshold required to detect all TOI, resulting in many investigations required for sources that are too small to be TOI. The ability to reject these targets presented a 60% reduction in the number of required cued investigations.

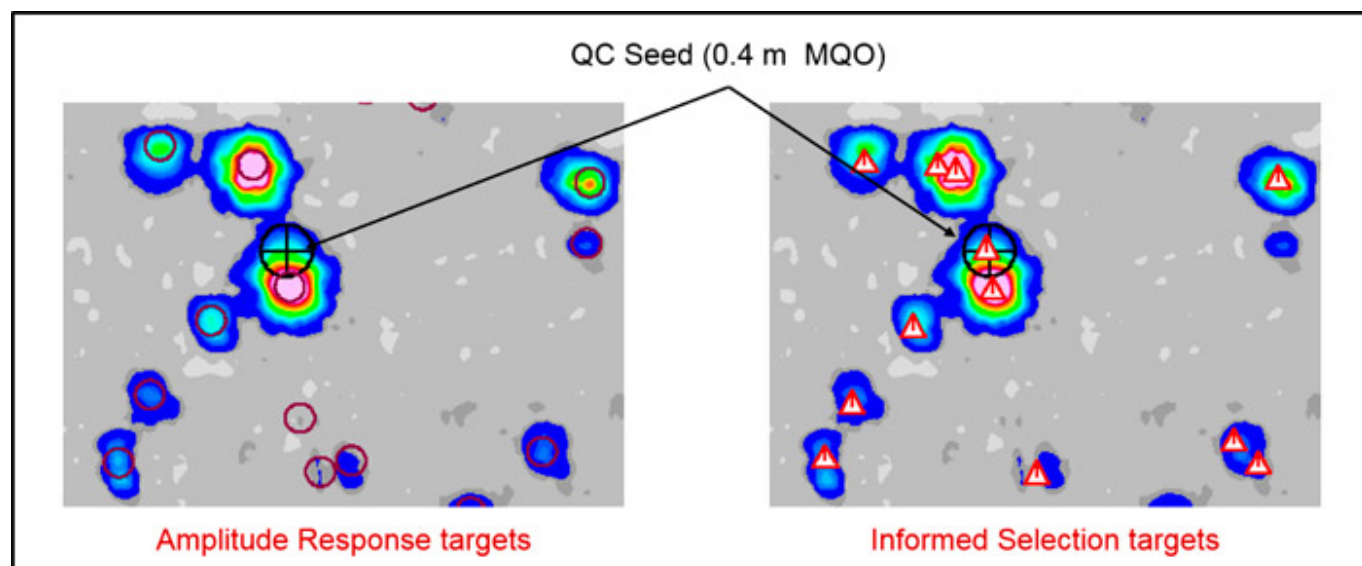
**Figure 9-6. AR vs ISS overlapping signatures. Left panel: Amplitude response detection failed to detect a seed that is masked by an overlapping signature. Right panel: ISS correctly detects the seed item.**

A third advantage of ISS detection is that it detects and accurately locates sources with overlapping signatures. Figure 9-6 presents a situation where the response to a seed is masked by an adjacent signature. Amplitude response-based detection did not identify the seed as a target as it was not distinguishable from the larger adjacent source. Ordinarily, this reading would result in a QC failure; however, using ISS the two separate sources located with overlapping signatures are distinguishable from each other and are each selected for further investigation.

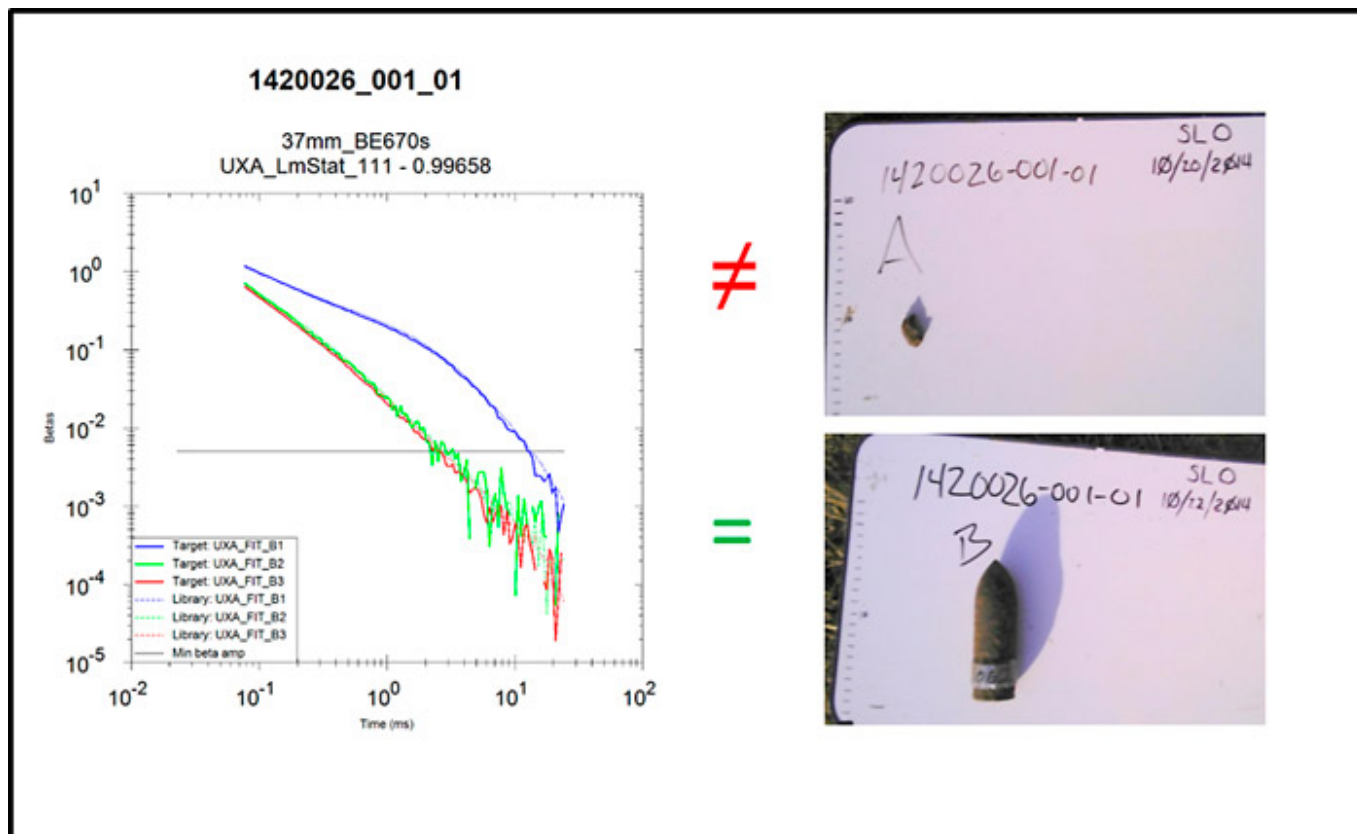
**Figure 9-7. Missed QA Seed. The initial dig result (top photo) for this location failed to recover the seed (bottom photo). The QC failure was identified by the contractor geophysicist when comparing the AGC predicted results (left image) to the dig results.**

*Intrusive investigation missed QA seed.* During the intrusive investigation process a QA seed was not recovered during the initial intrusive investigation. The AGC geophysicist reviews the intrusive results to confirm that the recovered item is a qualitative match to the AGC model results (illustrated in Figure 9-7). The purpose of this comparison is to provide a line of evidence that serves to validate the AGC process; however, this comparison also serves as a QC check on the actual intrusive investigation process.

During review of the intrusive results, the AGC geophysicist noted that only a small piece of frag was recovered at a location where the source was a perfect fit to a 37mm projectile. The dig team was asked to revisit the location and they recovered a 37mm projectile just outside of the 0.4 m dig radius.

A root-cause analysis revealed that the flag was not placed with the precision required to support the 0.4 m intrusive investigation radius. A short-term corrective action required review of all 'as staked' intrusive investigation flag locations and re-investigation of any locations found to be placed greater than 15cm from the intended location. The recovered 37mm projectile was determined to be a QA seed. Although this seed was blind to the contractor, it was discovered through the contractor's QC process.

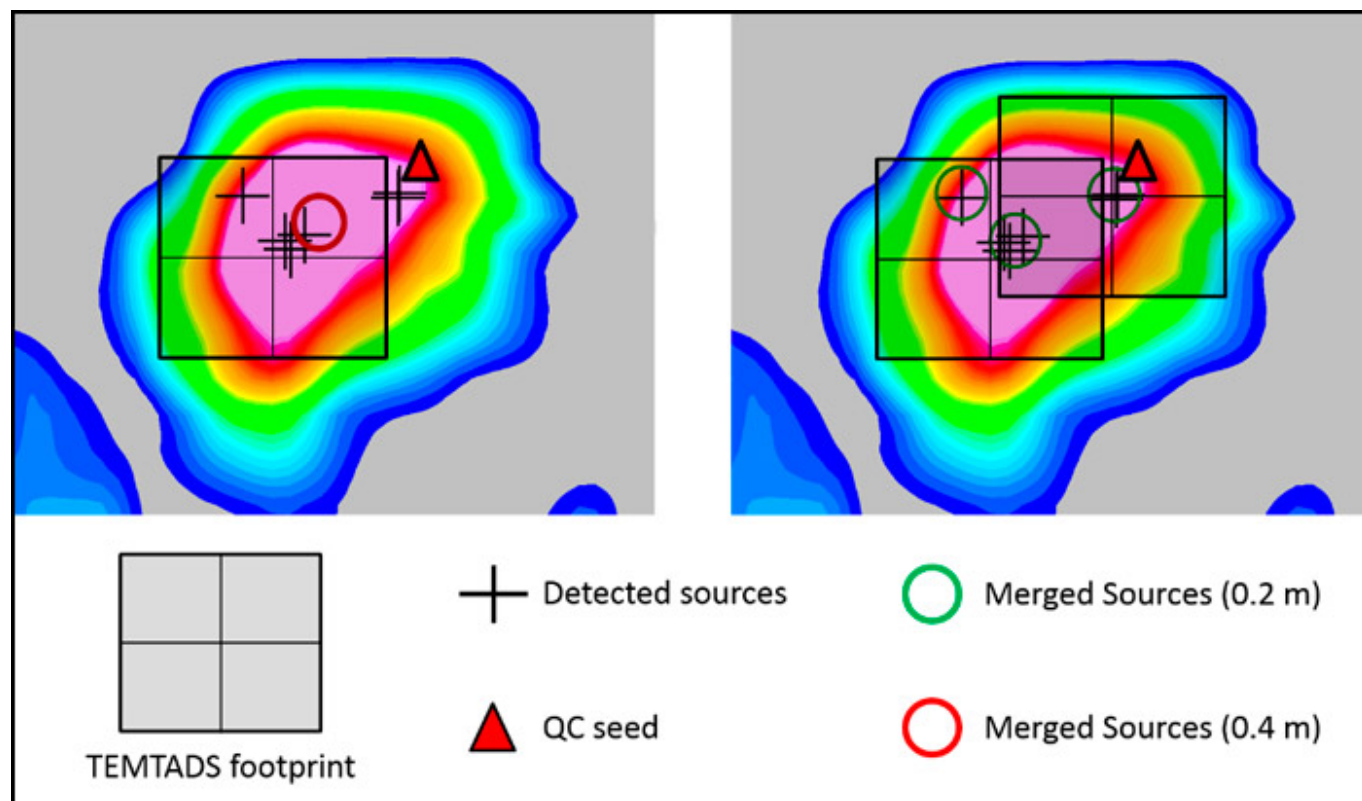
**Figure 9-8. Misclassified QC seed. Left Panel: Using a 0.4m merge radius, the QC Seed (red triangle) did not fall under the TEMTADS 2x2 footprint for the resulting target location (red circle). Right Panel: using a 0.2 m radius a separate target is identified resulting in a TEMTADS 2x2 measurement over top of the seed (and correct classification of the seed).**

The original merge threshold was set to 0.4 m (a value typically used to merge closely spaced sources on conventional DGM surveys). The results for this merge are presented on the left side of Figure 9-8. The merged location (red circle) was within the MQO of 0.4 m from the seed item, so the seed was judged to be detected. The sensor (shaded square) was positioned within 0.2 m of the merged location (again within the MQO for sensor/target location separation). However, the final distance between the actual seed location and the center of the array was just under 0.6 m and the seed was not properly interrogated by the sensor.

The corrective action for this case resulted in remerging of the identified sources using only a 0.2 m merge radius. As shown on the right side of Figure 9-8, this remerging resulted in the identification of two targets for cued investigation with the seed being properly interrogated and classified as a TOI.

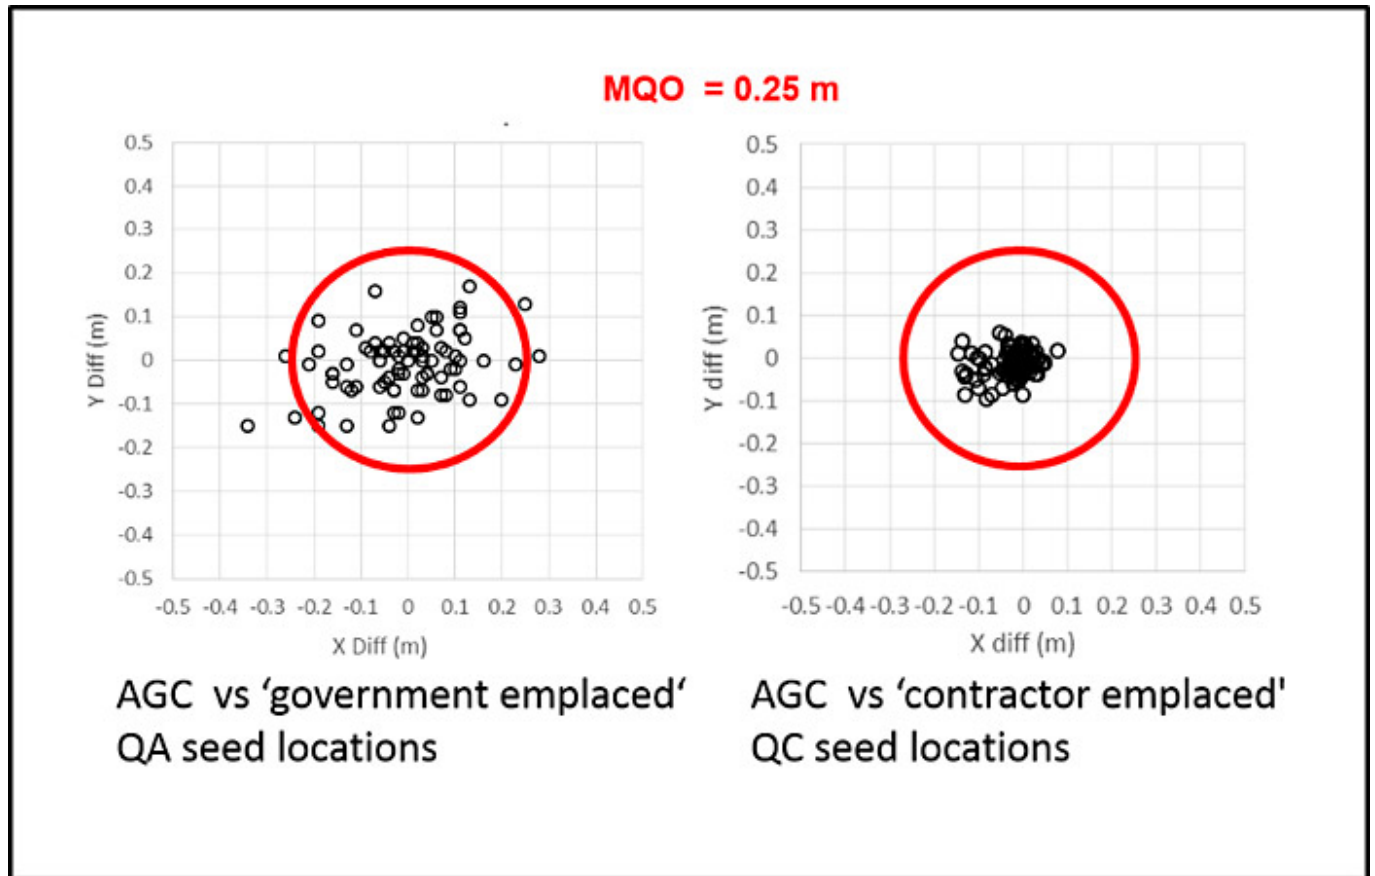
**Figure 9-9. QA vs QC seeds. Positioning performance against government employed seeds (left panel) was not consistent with the performance against the contractor employed seeds.**

**QA Seed Positioning Accuracy.** After final delivery of the results, the MQO for positioning accuracy for the government emplaced QA seeds was not met. A comparison with the accuracy performance for the contractor emplaced QC seeds (Figure 9-9) suggested that the problem was the accuracy of the QA seed ground truth. Review of the procedures used to derive the ground truth positions reveals that the seed locations were measured before the seeds were emplaced, thus the

measurements were not precise enough to support their use as a quality monitoring tool. This finding resulted in no required corrective action other than documentation as a lesson learned.

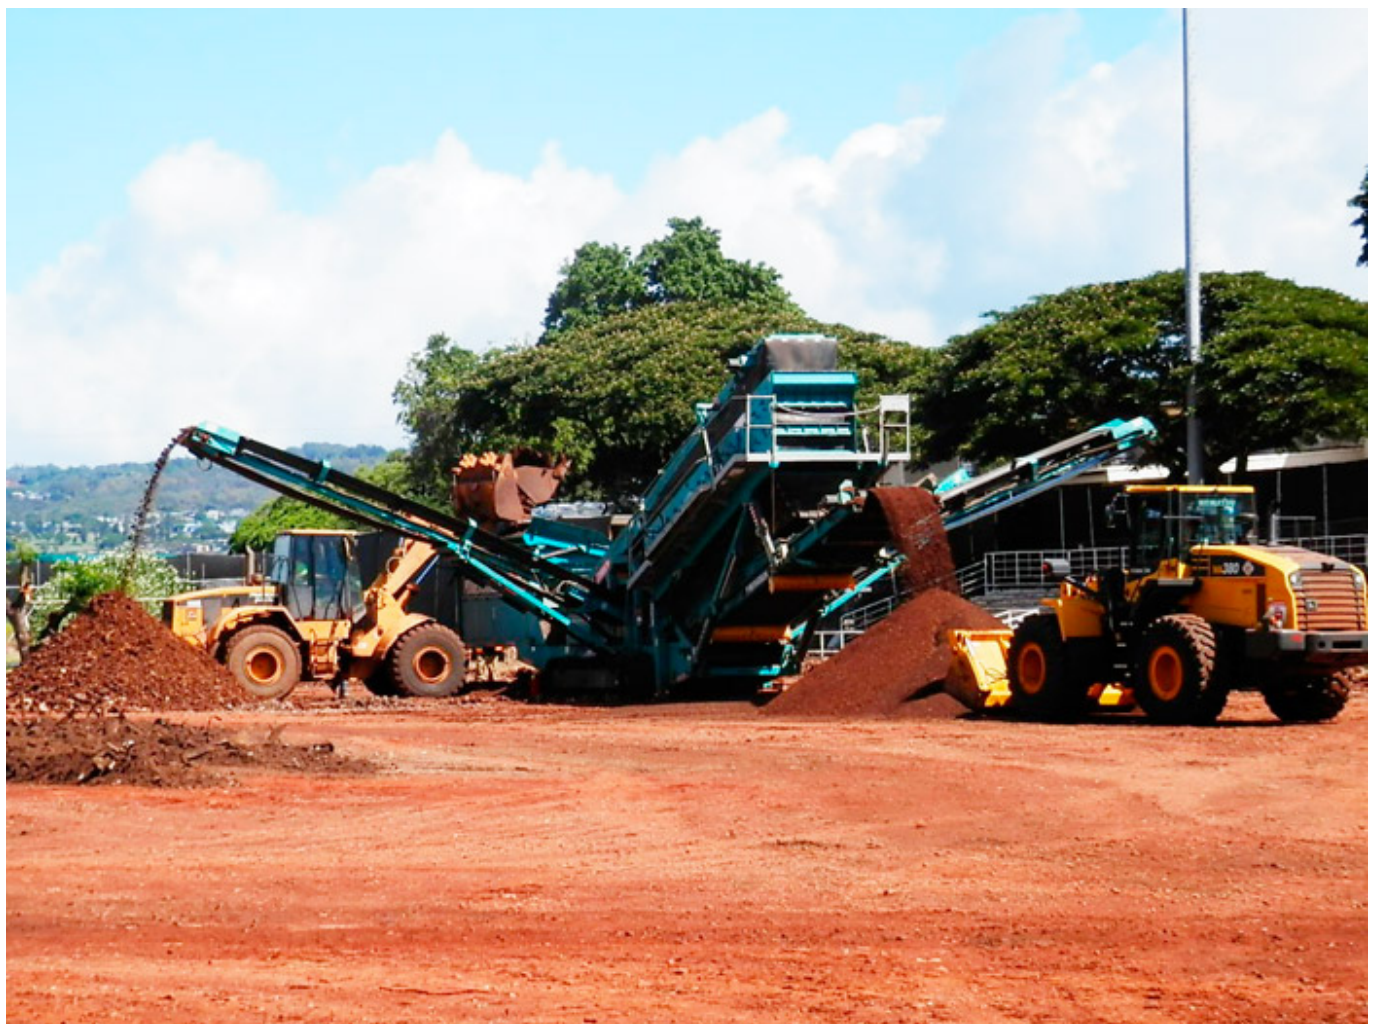
**Figure 9-10. Official US Navy photo. Screening plant with screened material greater than ¾ inch on the left and less than ¾ inch on the right.**

The UXO contractor used excavators, backhoes, bulldozers, and front-end loaders that provided the minimum separation distance required for the munition with the greatest fragmentation distance (MGFD) to conduct all excavation activities. The mechanical screening operations involved the use of (1) front-end loaders and excavators for loading and transporting soil/debris; and (2) a mobile mechanical screen. A UXO Technician II (or III) performed visual monitoring of the screening operation from the approved (K24) distance from the closest discharge of material that could potentially contain MEC. When MEC or MPPEH was identified during the screening operations, the UXO contractor temporarily halted the screening operations using a remote or emergency stop switch and performed MEC and MPPEH inspection and handling in accordance with the ESS. The UXO contractor resumed screening operations following safe removal or disposal of the identified MEC or MPPEH. Oversized materials (over ¾-inch) were spread out (no deeper than 8 inches) in an adjacent area and visually searched with the aid of handheld detectors to ensure no MEC or MPPEH was present. Figure 9-10 shows the screening plant in operation. Figure 9-11 shows the screened material spread out for inspection.

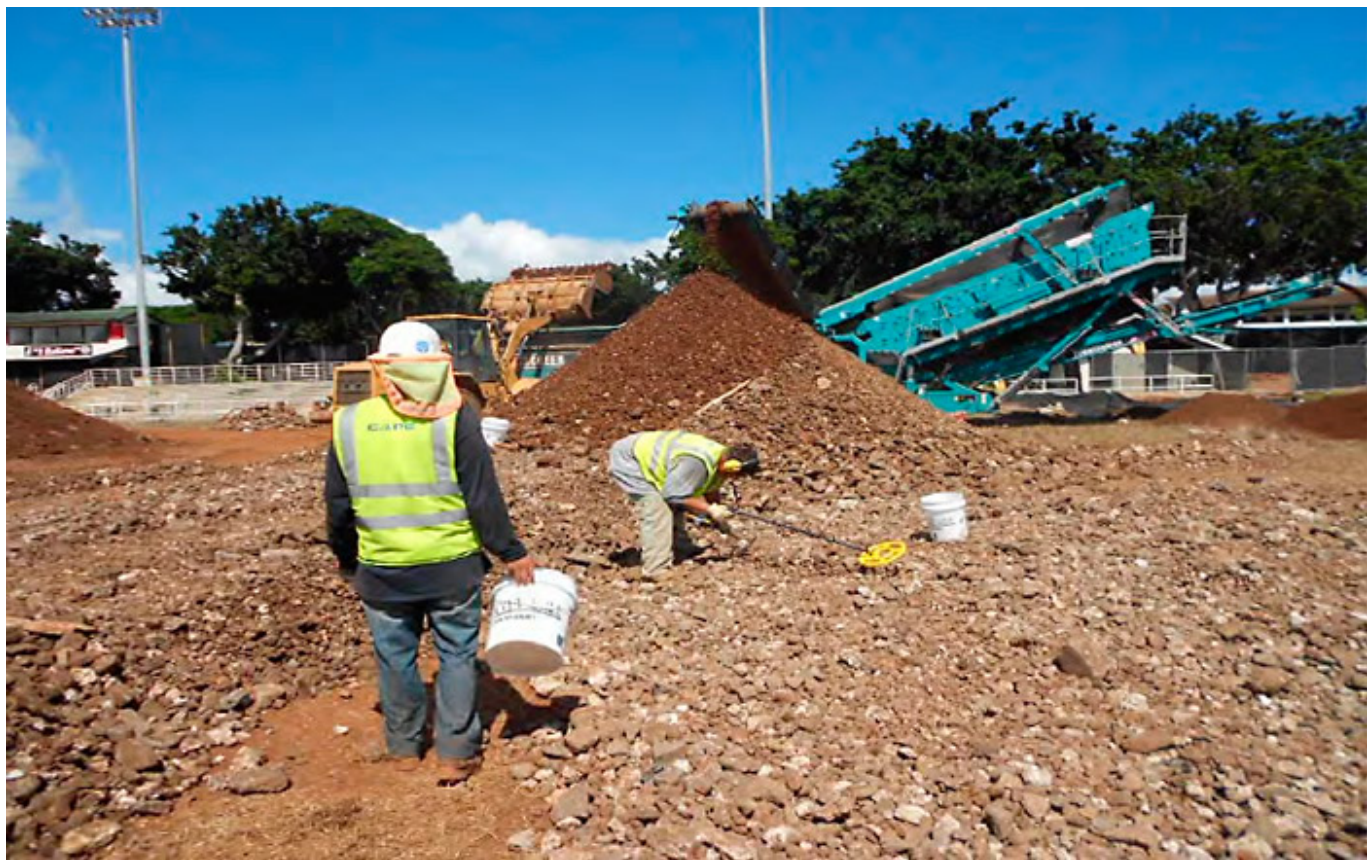
**Figure 9-11. Official US Navy photo. Sweeping ¾ inch + spoils with a Whites all metals detector.**

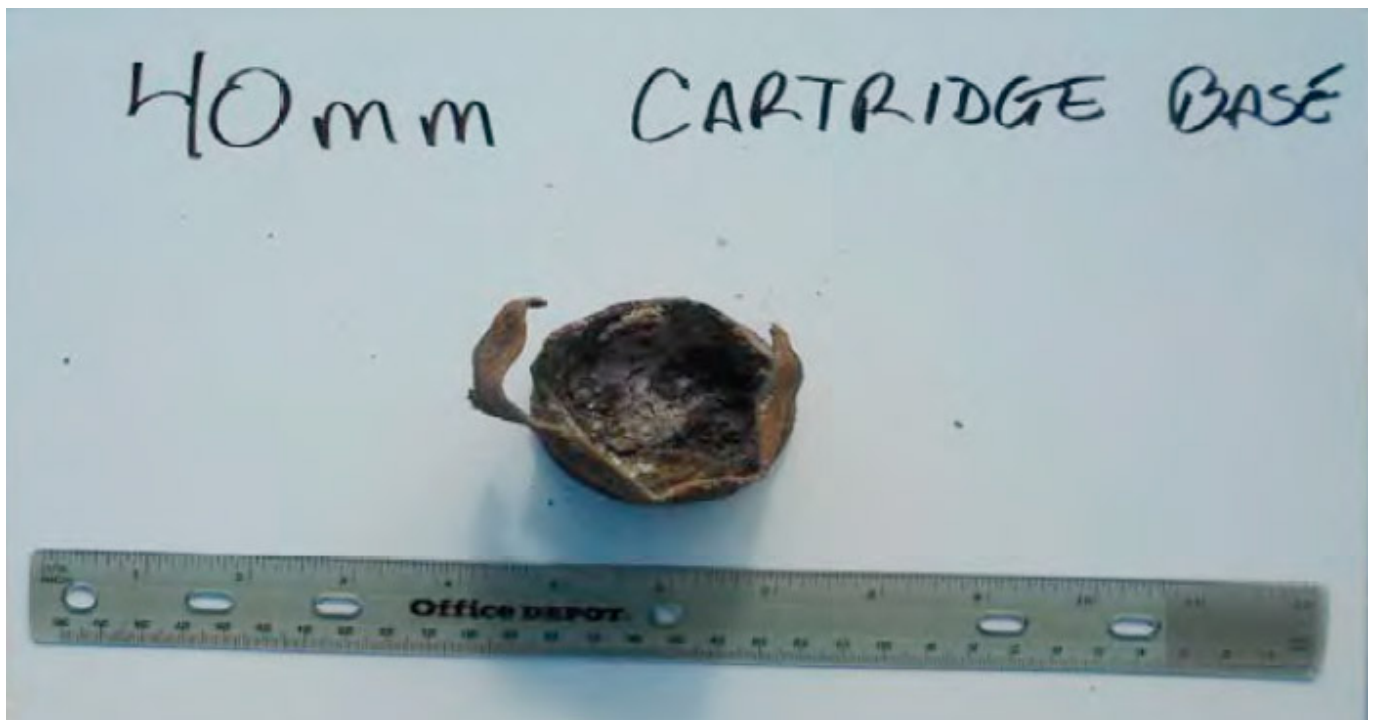
**Figure 9-12. Official US Navy photo. 40mm Cartridge Base recovered from 3/4 inch + spoils.**

After processing the soil through the soil screening operations, over 800 munitions related items were identified. Each of these was assessed and all of them were determined to be material documented as safe (MDAS). Figure 9-12 shows one of the munitions related items, a 40mm cartridge base. Figure 9-13 shows some of the miscellaneous metal debris recovered at the site.

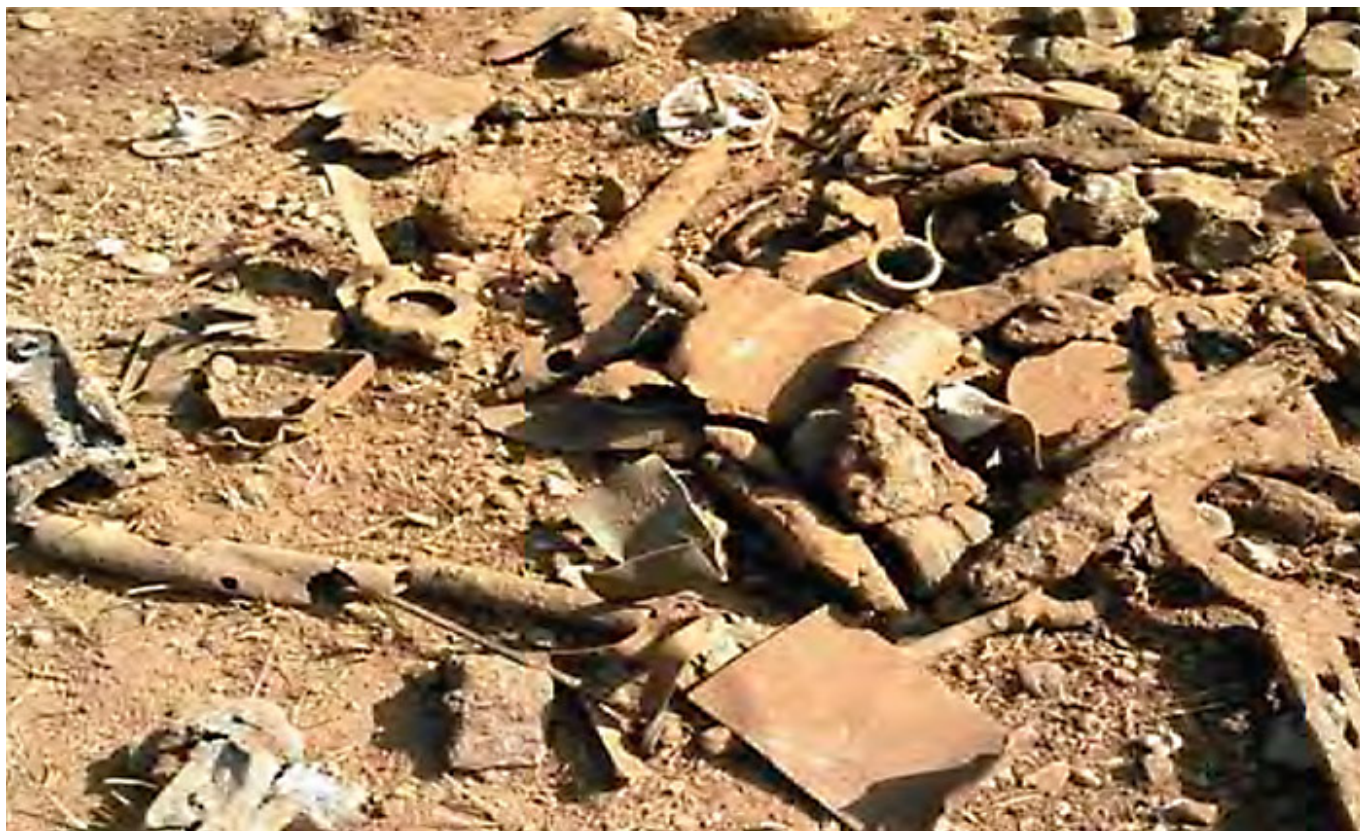
**Figure 9-13. Official US Navy photo. Miscellaneous metallic debris recovered from 3/4 inch + spoils.**
